Douglas Flat Schoolhouse

Historic Structure Report

Prepared for
Douglas Flat Community Center

January 29, 2019

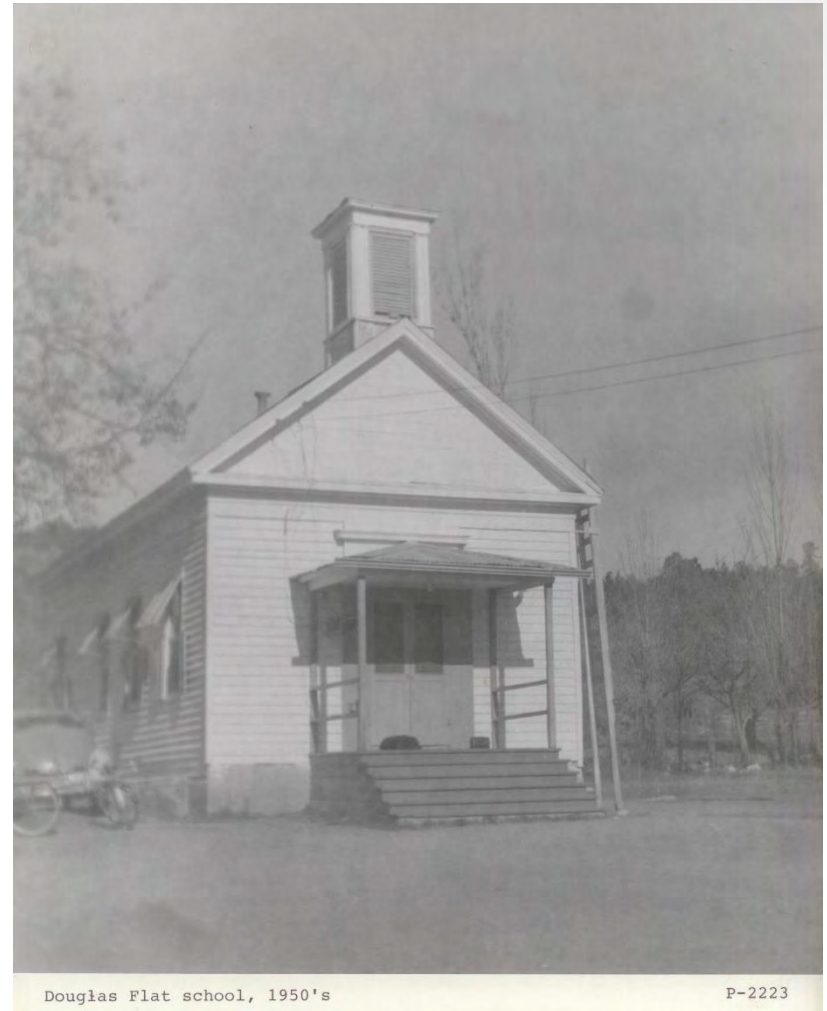
View 10: DFS (ca. 1950s) Note cresting & flag pole gone,
 new corrugated metal roofing likely
 from roof, porch modified, shutters & ladder still
 extant, double doors changed, concrete at parts of
 foundation walls (see 1925 view)

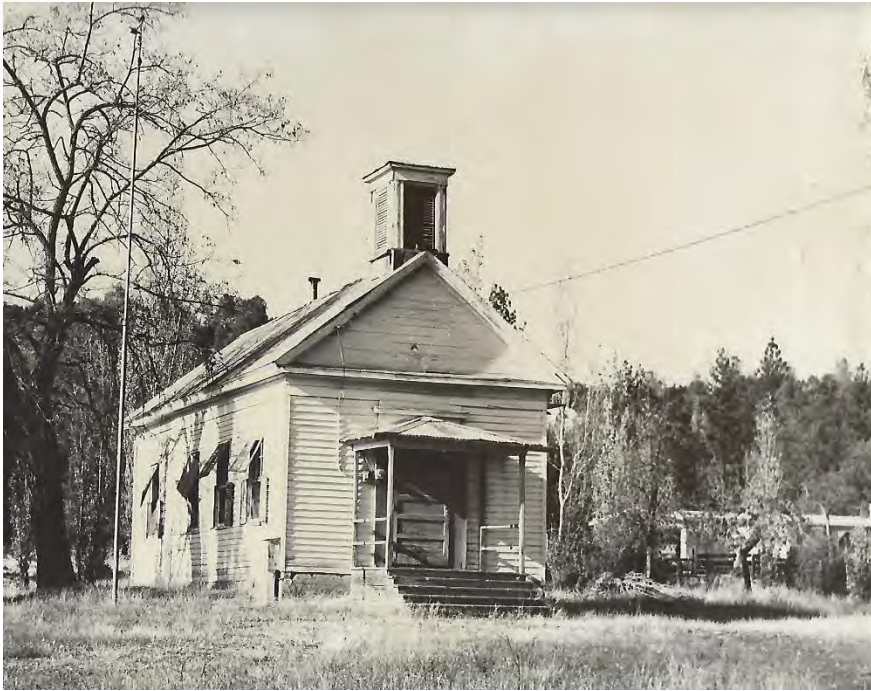
View 11a: DFS (Jan. 1971) Note single front door, lower left side at front: electric entrance, and concrete foundation distressed

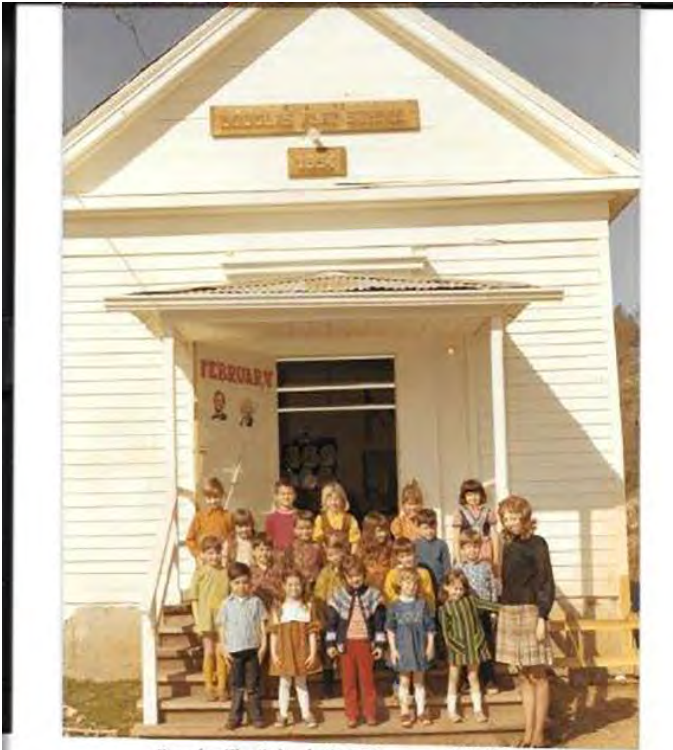
View 13: DFS Class of 1972. Note condition of concrete foundation

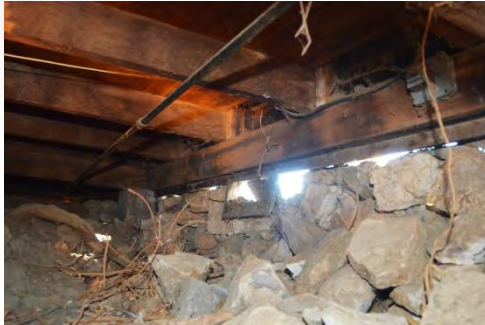
The building should be returned to plumb and level before any other repairs (like flooring) are made. The stone foundation is in very poor condition. Over time many of the stones have fallen out of the wall, or been removed, and the entire structure has tilted and racked, causing great stress on the wood frame and resulting in out of plumb walls, and a floor that slopes in different directions. This has occurred very slowly over a long period of time. Some foundation repairs have been made over the years as each wave of repairs were done – most notably at the front where a concrete wall has replaced the stones, and at a couple of locations around the perimeter where concrete piers have been installed. These previous repairs are unsightly and detract from the preservation of the stone wall, but they have provided some support for parts of the building.

The exterior of the section of the stone foundation wall depicted in the photograph looks to be largely intact from outside the building. However on the interior side, where the photo (*left*) was taken, stones are tumbling down and not really supporting the wall, and water stains can be seen on the inside of the siding and extending down over the horizontal 4x wood plate at the top of the stone wall.

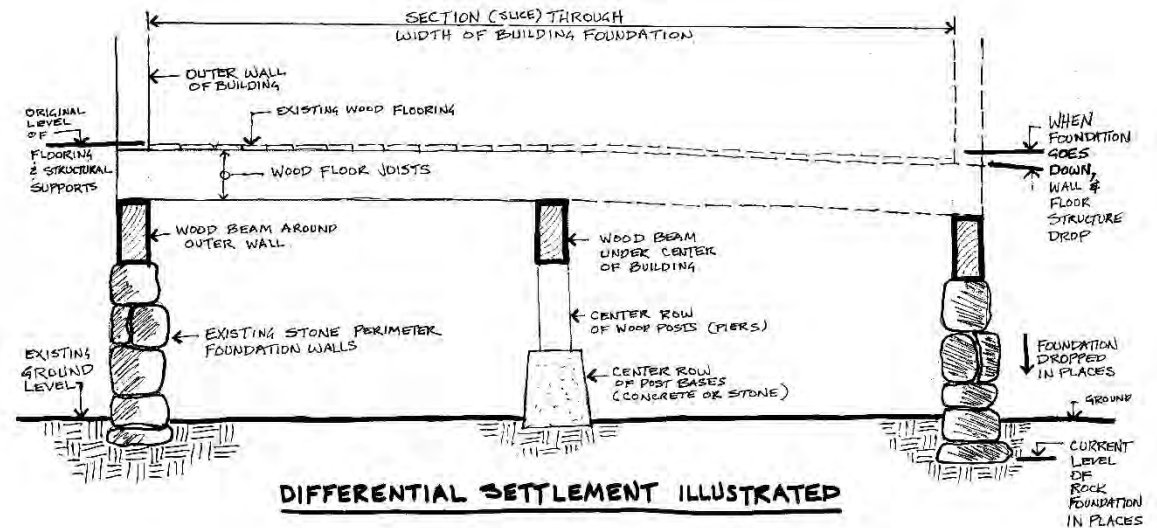
Nevertheless, what we see here is that the floor is not level, and it has advanced far enough that the walls are tilting a little. Since its an old building, we tend to excuse this. What we often don't realize is that, left unchecked, the wood frame will slowly destroy itself through this differential settlement. Gaps and openings in the exterior wood pieces, most visible in the trim along the connection the roofing and at the vertical corners near the roof (*right*), have been initiated by this settlement. This lets water into the wall where it causes further rotting of the wood causing the gaps to open wider, speeding up the cycle of wood rot and general deterioration of the entire building. Insufficient foundation support (i.e. the stones falling out of the wall) is the root cause. Of course, the distortion of the wood building frame is helped along by the deteriorating paint on the siding letting

water intrude into the walls. This latter issue is discussed under **Siding** (*below.*) The main cause of the uneven settlement of the entire structure is the increasing deterioration of the stone foundation walls.

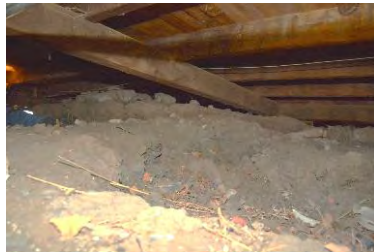
Sitting atop the dirt in the photo (*right*) are the remnants of the stone foundation wall of the rear of the original schoolhouse – before the first addition. (See Part I for a discussion of this as a possible apse for the church.)

According to the SIS, this should not be disturbed as it is evidence of this change. However, right now it appears to be holding up the center of the floor framing causing further distress to the flooring, including breaking or splintering of some flooring pieces (see flooring discussion below.) But the root cause of the warping floor is not the old foundation in the center holding the

floor up, it is that the outer walls are sinking, forcing the flooring down at the walls. This is what the illustration is showing on the previous page. This is called ‘differential settlement.’

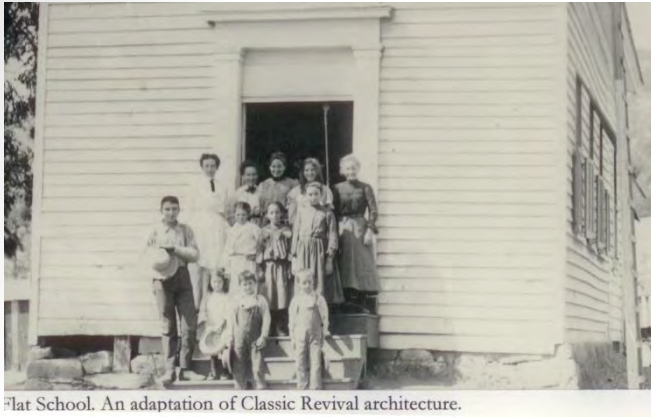
Close examination of the photo on the cover of *Las Calaveras*, (see Part I - Appendix, historical view 7, and close-up on next page) one can see two important additional details about this foundation. First, the stone walls are wider at the base. This “battered wall” shape where the walls tilt in at the top also helped spread the load. This is still evident in the shape of the wall today.

Second, a wood pier is evident at the left side of the front where stones have fallen out. Initially, the building was probably supported by just the piers, including at the perimeter. Over

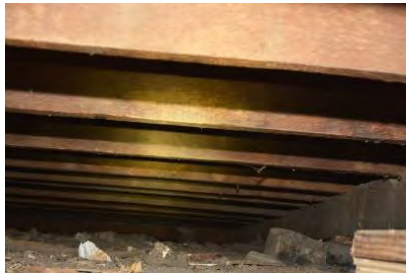
The photo (above right) is of the outside of the same wall depicted on the preceding page. It shows the connection of the stone foundation on the left side of the picture to the concrete foundation of the modern addition at the right side. Note the lichen growing on the outside. This is further evidence of moisture being trapped in this area outside, as well as inside, the foundation walls.

For decades, local building codes have required minimum clearance from soil to wood framing members of 18” to wood floor joists and 12” to wood girders. The photograph (right) is typical of many places under the schoolhouse where the wood girder (lower right in photo) is almost touching the soil and the joists (running horizontally across the photo) are only 4” away from the soil.

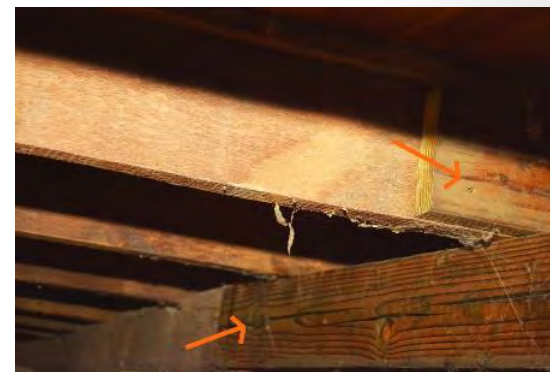
The floor joists are spaced 22” to 25” apart. Although this was typical of this era, it results in floors that are ‘bouncy’ when walked upon as the thin flooring boards are spanning two feet or more between joists. Also, the new flooring was laid directly on the joists, no supportive subflooring is evident. The new flooring is likely thinner than the old planks and so the span, at almost 2 feet is too great (see P.4.2, Flooring below). Some repairs to strengthen the joists and girders have been made, but they are not sufficient because the cracking and breaking of floorboards continues.

While it is important to strengthen the floor framing before repairing the flooring, repairs to the floor joists and to the flooring should not commence until after the building has been returned to plumb and level. (see Floors below.)

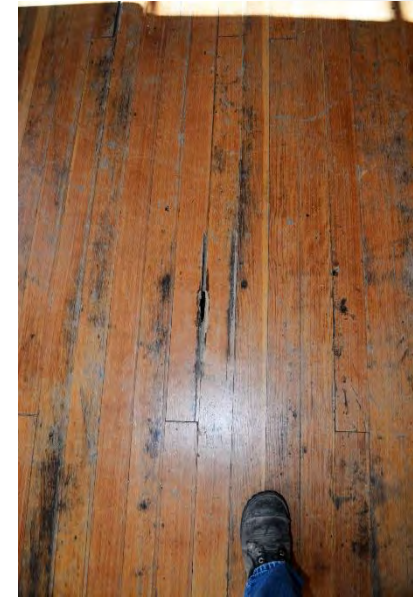
This flooring is being stressed and is cracking and breaking due to the material bouncing up and down when walked on. This occurs because there is no subfloor (there never was) and the joists are too far apart to properly support this newer, thinner flooring material. Another stressor is the differential settlement of the outer walls dropping while the original foundations of the back wall and the apse section hold the center high as discussed elsewhere (*see Differential Settlement Illustrated under 4.1.1*). As long as boards continue to flex the cracking and holes will continue to appear.

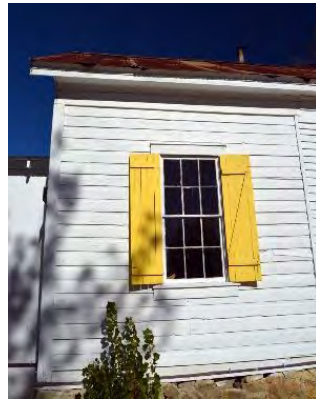
Note the exterior window trim in the 1870 addition (*photo right*) is slightly more ornate, more characteristic of the Greek Revival style, than the older windows. These differences are important clues as to the age of construction and should be maintained and preserved according to the SIS.

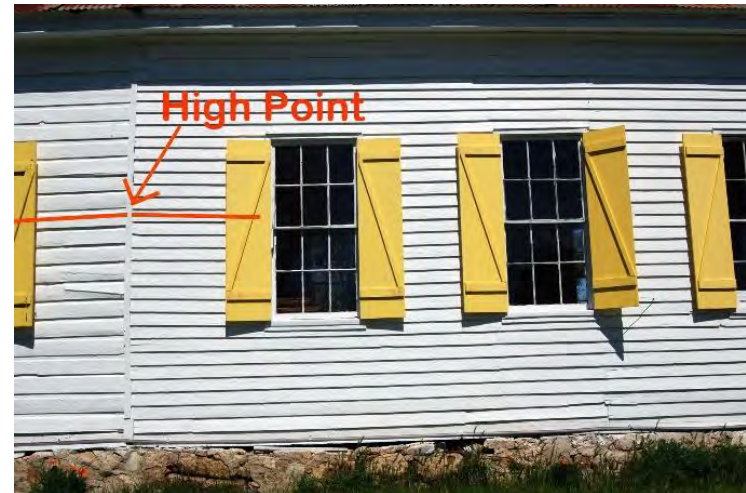
The frieze board at the top of the siding is correct and is another character-defining detail. It should be checked for gaps, etc. and repaired with the specified epoxy if necessary. It and all other trim of the siding should be preserved following SIS and the information given in the resources in the Appendices.

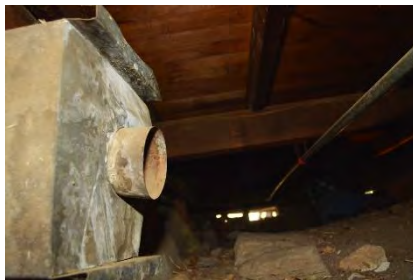
A gravity wall furnace has been placed in the main room on the left wall. There are no ducts nor blower for this furnace, so it is

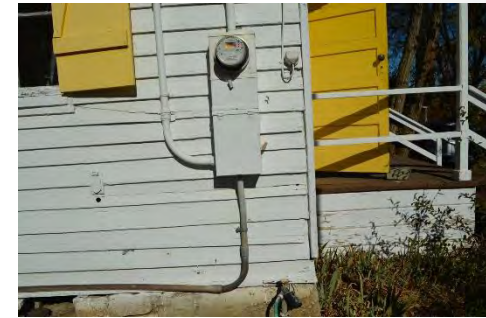
The electrical service enters the building at the front left. (Photo right.) The panel and meter is exposed on the exterior and a small breaker board was added inside. The breaker panel is acceptable if painted to match the wall, as it is relatively unobtrusive. However, as can be seen in this photograph, the exterior portion is an eyesore. We encounter this problem on many historic buildings. Our solution is to hide this modern equipment with a small wood enclosure with a sloped, shingled top and a hinged door on the front. Electricians call this a “doghouse” because of its general shape. These enclosures are found on buildings as old as the 1910s and 20s when they often contained fuses and the main shut-off for the electric power. Its construction can be simple with sides composed of siding to match the schoolhouse, topped by a small, sloped roof with a few shingles on it. A new conduit was added a few years ago below this service panel. It is surface mounted just above foundation and extends all the way to the back of the building. Not only is this unsightly but the sunlight has caused it to discolor and distort such that the sagging plastic conduit does not look good. As soon as possible, this conduit should be rerouted into the crawlspace so that it is hidden from view. The
