Douglas Flat Schoolhouse

Historic Structure Report

Prepared for
Douglas Flat Community Center

January 29, 2019

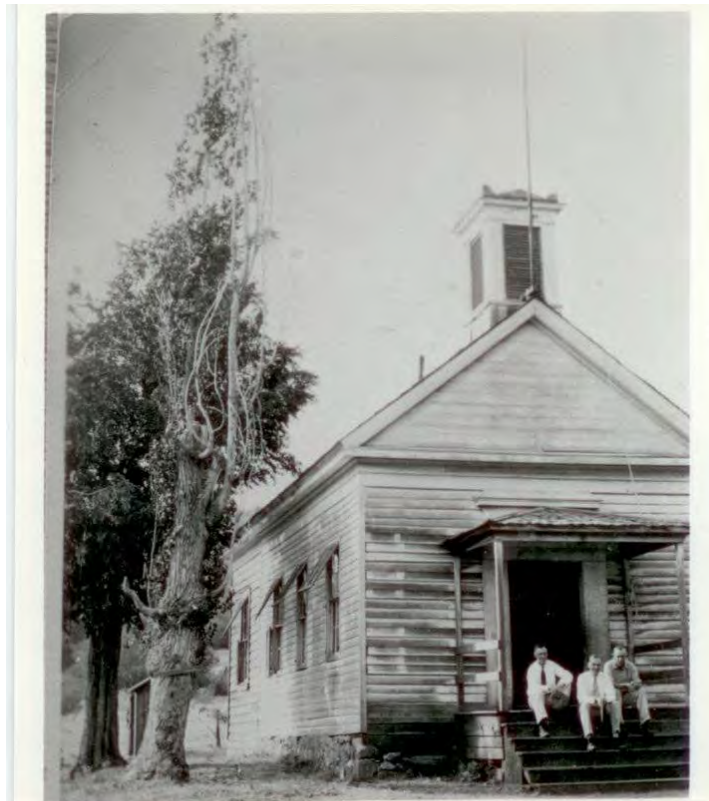
View 8b: DFS (ca. 1925) Note cresting on Belfry & flag pole at front of roof peak

Frame pinnacles once decorated each upper corner of the tower, separated with narrow pediments (Elliott 1885:34, Calaveras County Historical Society 1986:39, (*Views 1-8b*), but were no longer extant by the 1950s (*View 10*). We refer to this decoration at the top as cresting and it is similar, albeit simpler, to that used on the Murphy’s School bell tower and front porch (*View 5.*) To better comply with Restoration Standard #’s 5, 6 & 7 of the SIS (*Appendix P.2.1*), this character-defining feature should be reconstructed, complete with all trim, using photographic evidence and full-dimension lumber.

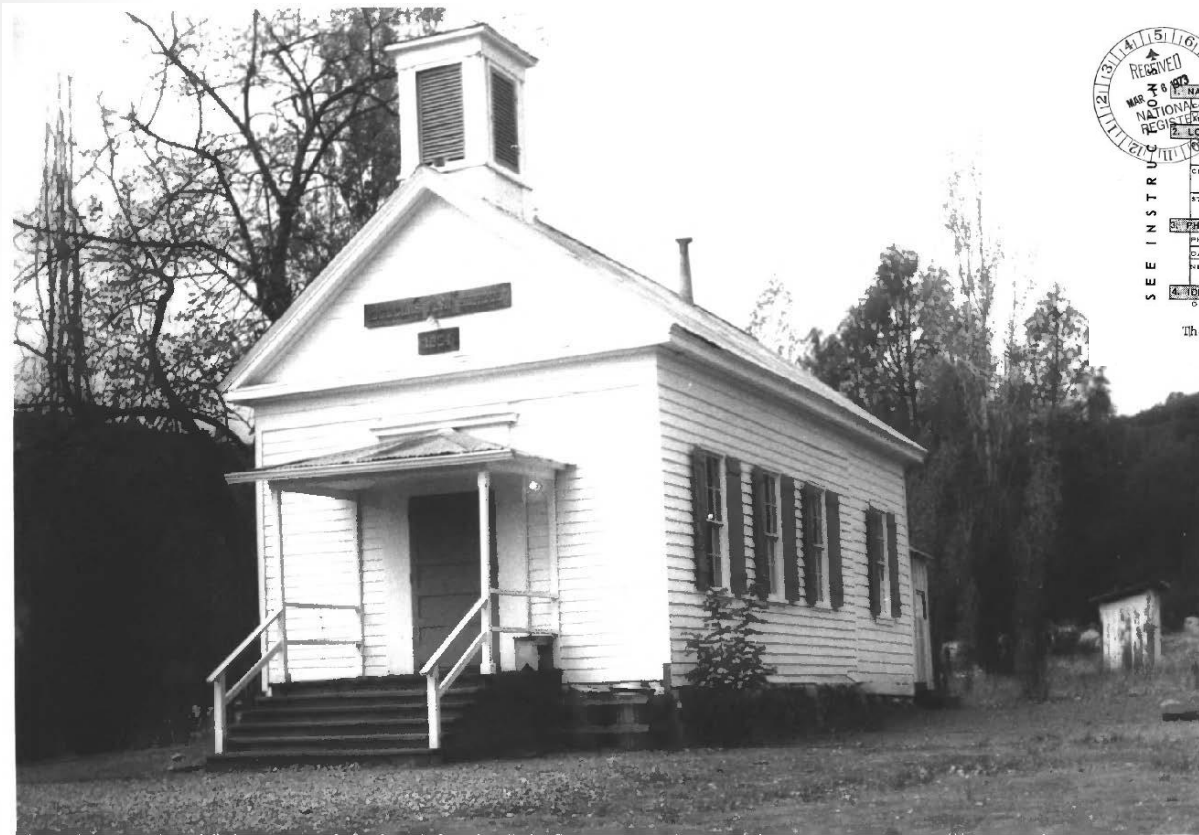
View 12: DFS (1971) photograph from the NRHP nomination forms. Note: Shutters changed .

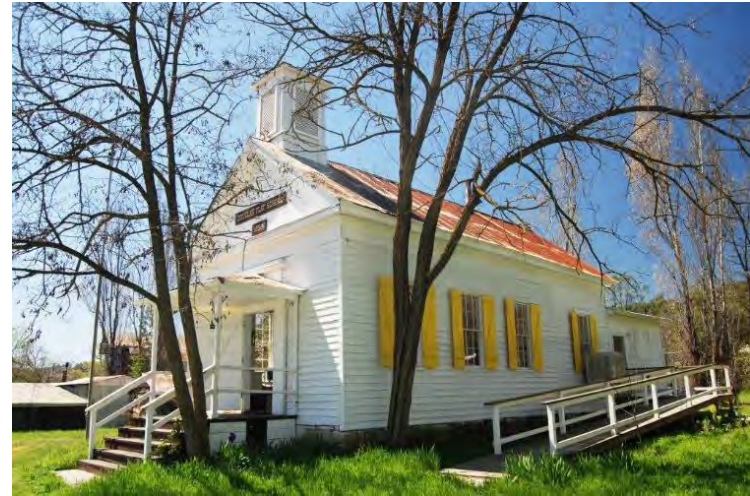
View 1: DFS View toward right side, 2011

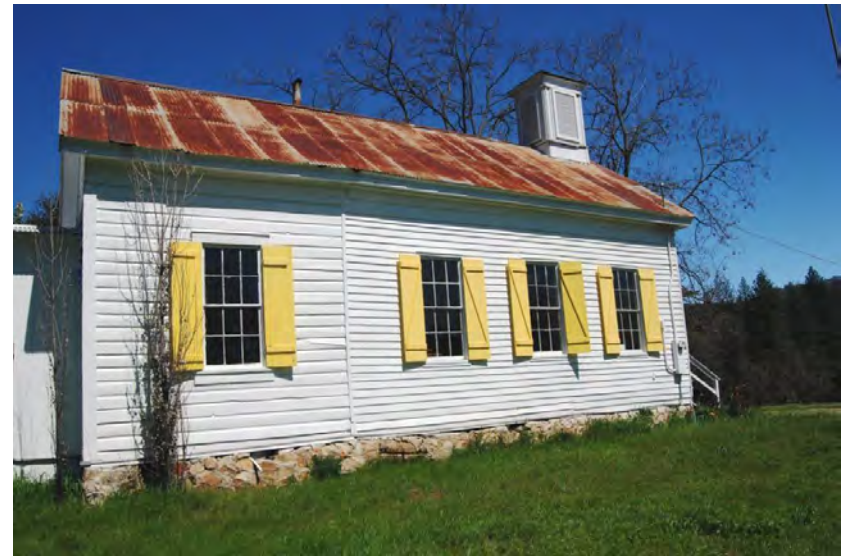
View 2: DFS View toward left side, 2011

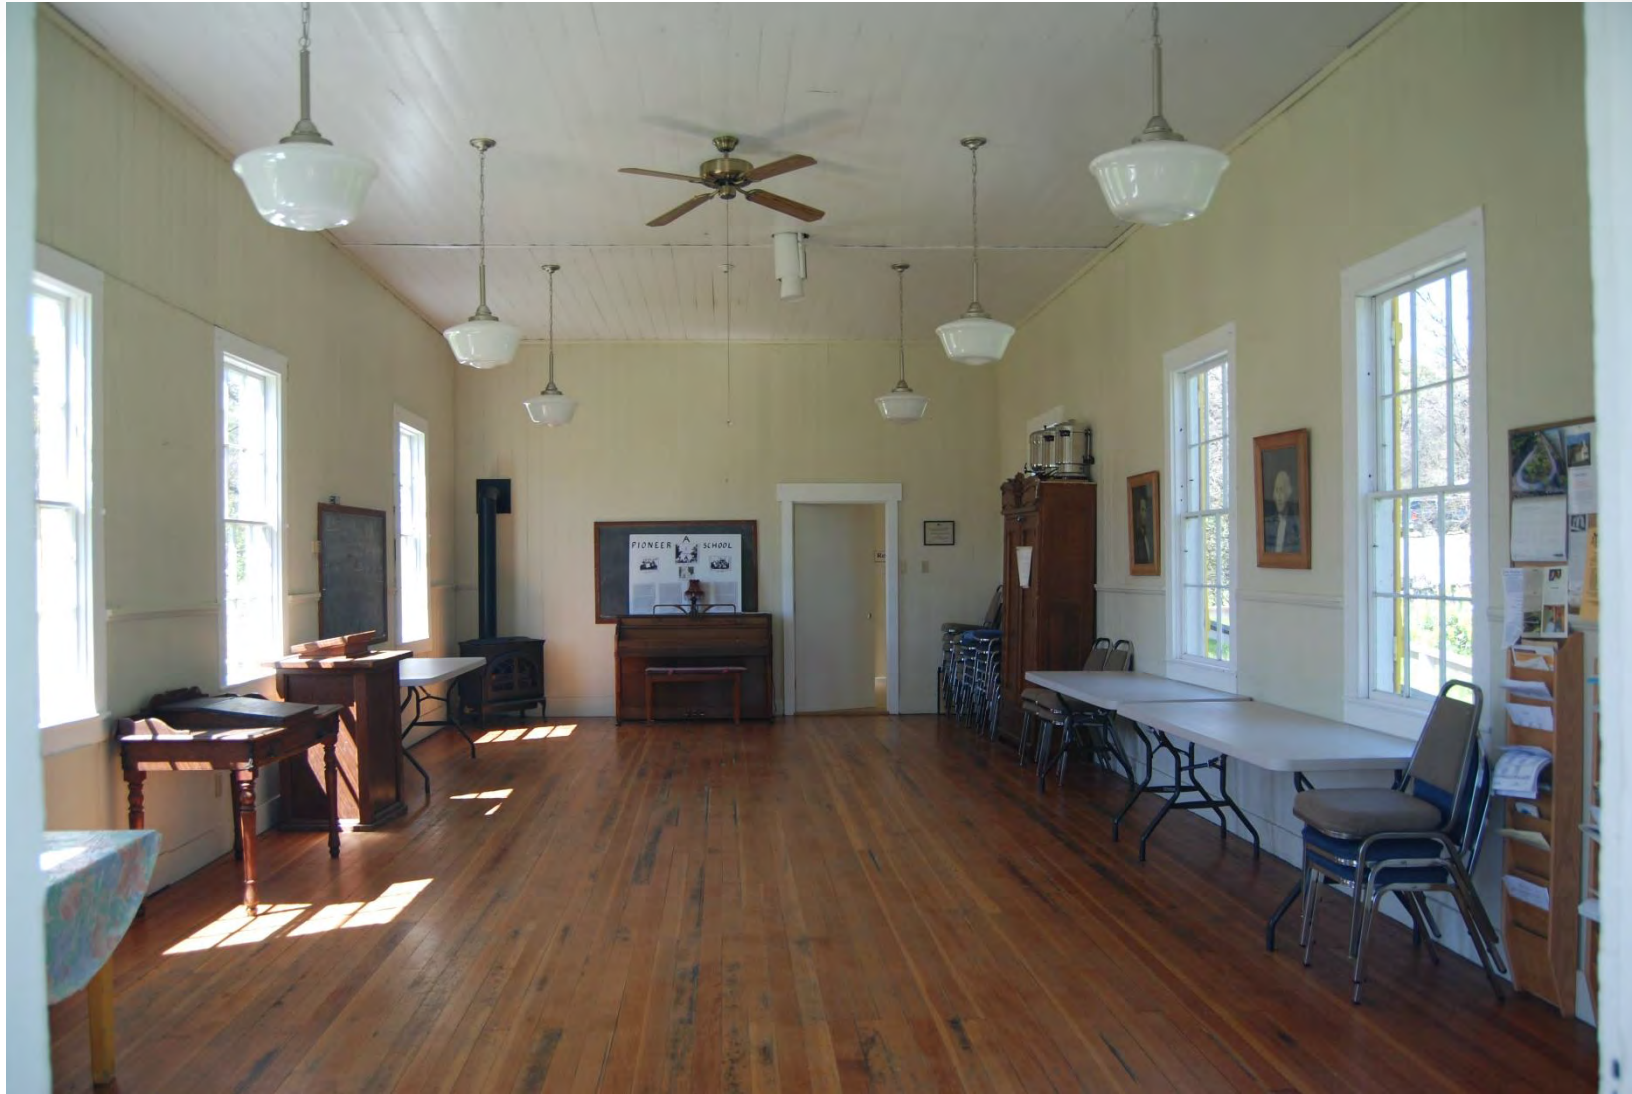
View 3: DFS Interior view toward rear of building, 2011

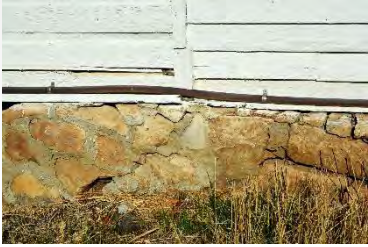
Nevertheless, what we see here is that the floor is not level, and it has advanced far enough that the walls are tilting a little. Since its an old building, we tend to excuse this. What we often don't realize is that, left unchecked, the wood frame will slowly destroy itself through this differential settlement. Gaps and openings in the exterior wood pieces, most visible in the trim along the connection the roofing and at the vertical corners near the roof (*right*), have been initiated by this settlement. This lets water into the wall where it causes further rotting of the wood causing the gaps to open wider, speeding up the cycle of wood rot and general deterioration of the entire building. Insufficient foundation support (i.e. the stones falling out of the wall) is the root cause. Of course, the distortion of the wood building frame is helped along by the deteriorating paint on the siding letting

water intrude into the walls. This latter issue is discussed under **Siding** (*below.*) The main cause of the uneven settlement of the entire structure is the increasing deterioration of the stone foundation walls.

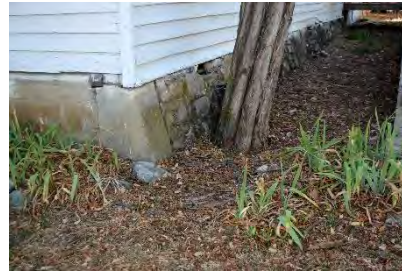
As noted, in recent decades, some repairs have been made. Most notably the replacement of the stones by a poured concrete wall at the front (see around both sides of front porch) and at a couple points along the side (*right*) poured concrete has replaced some of the absent stones. Also, some stones have been repointed with mortar. But ‘modern’ mortar has been used, which is too hard, and the freezing water causes the stones themselves to deteriorate by breaking off chunks and by eventually popping the entire stone out of place.

Sitting atop the dirt in the photo (*right*) are the remnants of the stone foundation wall of the rear of the original schoolhouse – before the first addition. (See Part I for a discussion of this as a possible apse for the church.)

According to the SIS, this should not be disturbed as it is evidence of this change. However, right now it appears to be holding up the center of the floor framing causing further distress to the flooring, including breaking or splintering of some flooring pieces (see flooring discussion below.) But the root cause of the warping floor is not the old foundation in the center holding the

floor up, it is that the outer walls are sinking, forcing the flooring down at the walls. This is what the illustration is showing on the previous page. This is called ‘differential settlement.’

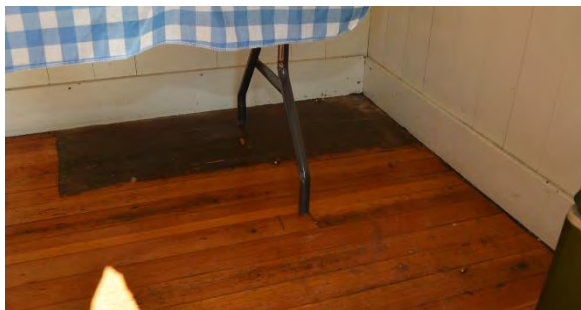
This flooring is being stressed and is cracking and breaking due to the material bouncing up and down when walked on. This occurs because there is no subfloor (there never was) and the joists are too far apart to properly support this newer, thinner flooring material. Another stressor is the differential settlement of the outer walls dropping while the original foundations of the back wall and the apse section hold the center high as discussed elsewhere (*see Differential Settlement Illustrated under 4.1.1*). As long as boards continue to flex the cracking and holes will continue to appear.

The photo shows a second cause of damage to the floor – water. Notice the black spots. These are caused by water getting under

the finish and staining the wood, but water also gets down between each board and eventually weakens it, which assists the cracking. Water can also be coming from underneath causing mold to grow. Either way, it is important that wet-mopping of the floor cease immediately and that proper ventilation of the crawl space occurs as soon as possible.

Floor repairs start with the jacking and leveling of the building (part of the new foundation process). Next the floor joists must be strengthened to carry the floor loads without having the flooring flex. This is why it would be more expeditious to replace the foundation and do the floor framing repairs first. .

Once the flooring is adequately supported, the damaged sections of boards can be cut out and replaced, as long as the replacement would be of the same species and has a similar or matching grain pattern and color. These short pieces are called Dutchmen by carpenters.

The black staining can be addressed by the judicious application of oxalic acid. There are a couple of the NPS technical bulletins on restoring wood floors which should be followed to assure compliance with the SIS. However once the stains have been removed, and the floor refinished, water should not be allowed on this floor! We find that many people wet mop a commercial wood floor to clean it and this should not be allowed. Damp mopping with an almost dry mop is all that is needed. Of course any liquid spills should be cleaned up right away before the liquid has time to penetrate in between the boards. (This could be written into your rental agreement.)

Instituting such a policy immediately would negate the need to fix flooring before repairing the

foundations – and we can't say this strongly enough. The cheapest way to fix the minimum amount of broken flooring is to do the foundation repairs first. Otherwise, you'll be fixing the floors again after they are leveled and reattached to the new foundation. A temporary fix for the larger holes would be to tack small, thin metal plates (using a coil of metal flashing perhaps?) over the holes. The holes left by the tacks or screws would be removed when the piece is cut out to insert the Dutchman.

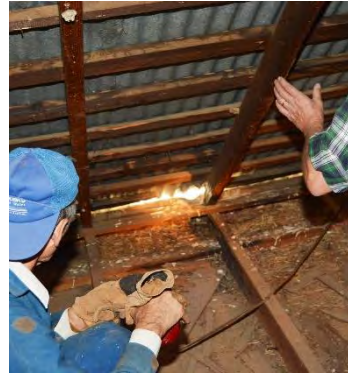
Bird droppings, straw, nuts and other debris has accumulated around openings in the eaves and elsewhere. (*See photo left.*) This is unhealthy to the building occupants as it spreads disease, and with the addition of moisture or dampness, can deteriorate the wood it is contact with. The debris should be removed immediately and temporary screening placed over the holes. Then, after the

building is plumb and level by jacking, the holes should be covered with the addition of repaired trim on the eaves and elsewhere. Flashing around the flue and other penetrations should also be rechecked at that time.

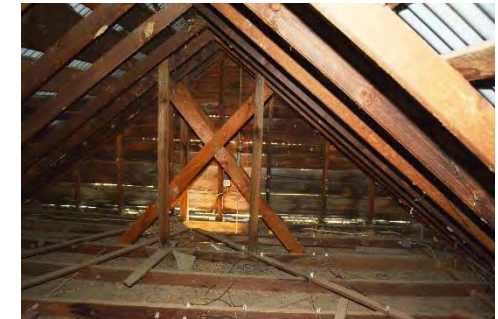
The siding boards on the gable end at the front have moved (*see photo*) and water is entering between them. In the photo, you can see daylight through the cracks. The back of these boards are waterstained, whereas there are no such stains on the opposite gable siding. These boards should be properly reattached to close these gaps, after the building has been leveled via the foundation work.

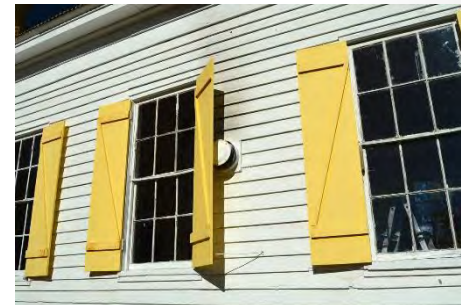
A gravity wall furnace has been placed in the main room on the left wall. There are no ducts nor blower for this furnace, so it is

not very intrusive. However, the exterior vent is problematic. Not only is it highly visible, it interferes with the operation and location of one of the exterior shutters. (*Exterior photograph showing vent, at right.*) One solution to this problem would be to relocate the exhaust duct to go straight up the wall (inside a code installed enclosure that is faced with wood paneling to match the wall) and into the attic. It could then exit through the metal roofing. The exhaust duct poses a safety hazard at its present location because if a window happens to be opened for ventilation, it could draw combustion exhaust into the space. For this reason, code says what distance this is supposed to be from windows. So not only would the exhaust be safer on the roof, it would improve the look of the historic exterior, and help it partially comply with the SIS. But an even better solution is discussed in the next section.

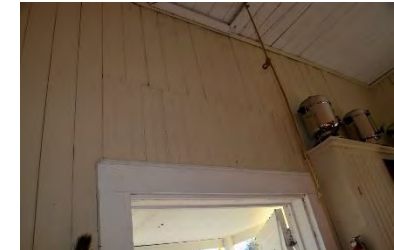
When the porch was added the transom window over the front door was covered, with a different style wood paneling (*right*). The window may still be there. Part I of this report says that the original door should reconstructed and the transom exposed and restored.

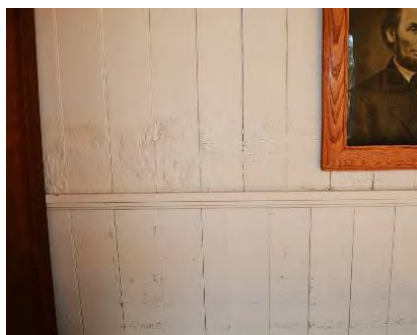
The photo at right shows two sizes of baseboards in the two different parts of the building. Their authenticity is discussed in the section on Wood Flooring (*above*).

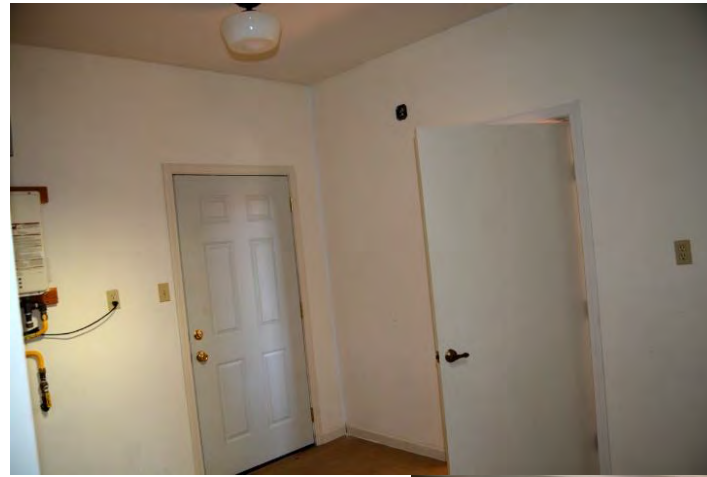
(Above) New main room with door to outside in center left of photo and door to schoolroom on center right. Water heater is at far left.

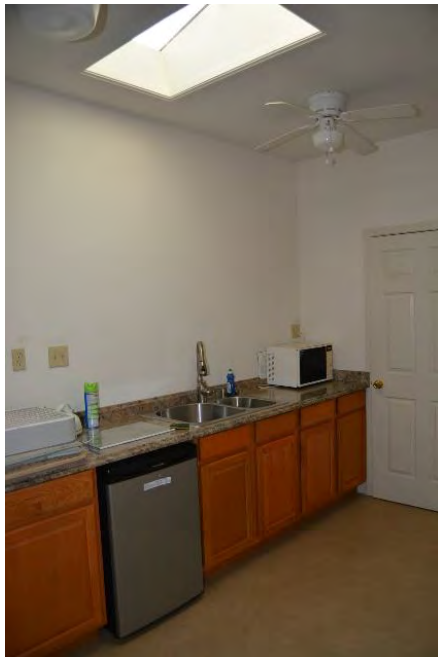
New kitchen cabinetry

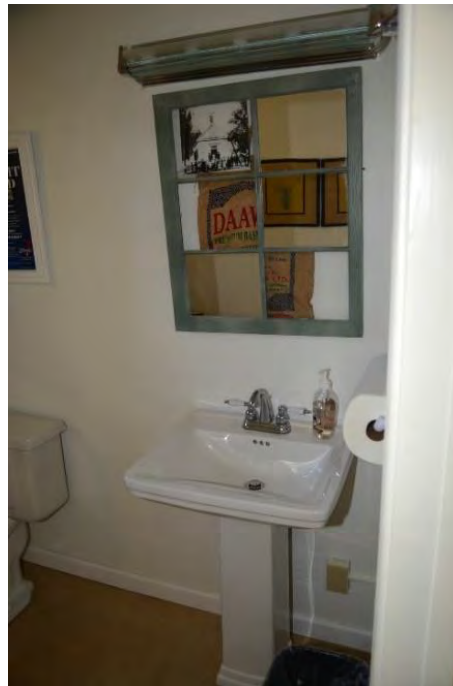
New publicly accessible restroom seen from main room of addition (right)
